## **A Geomorphic Enhancement for Flood Control**

Behnam Soleimani<sup>1</sup>, Dennis C. Seibel, P.E.<sup>2</sup>, and Robert E. Moyer, IV<sup>3</sup>

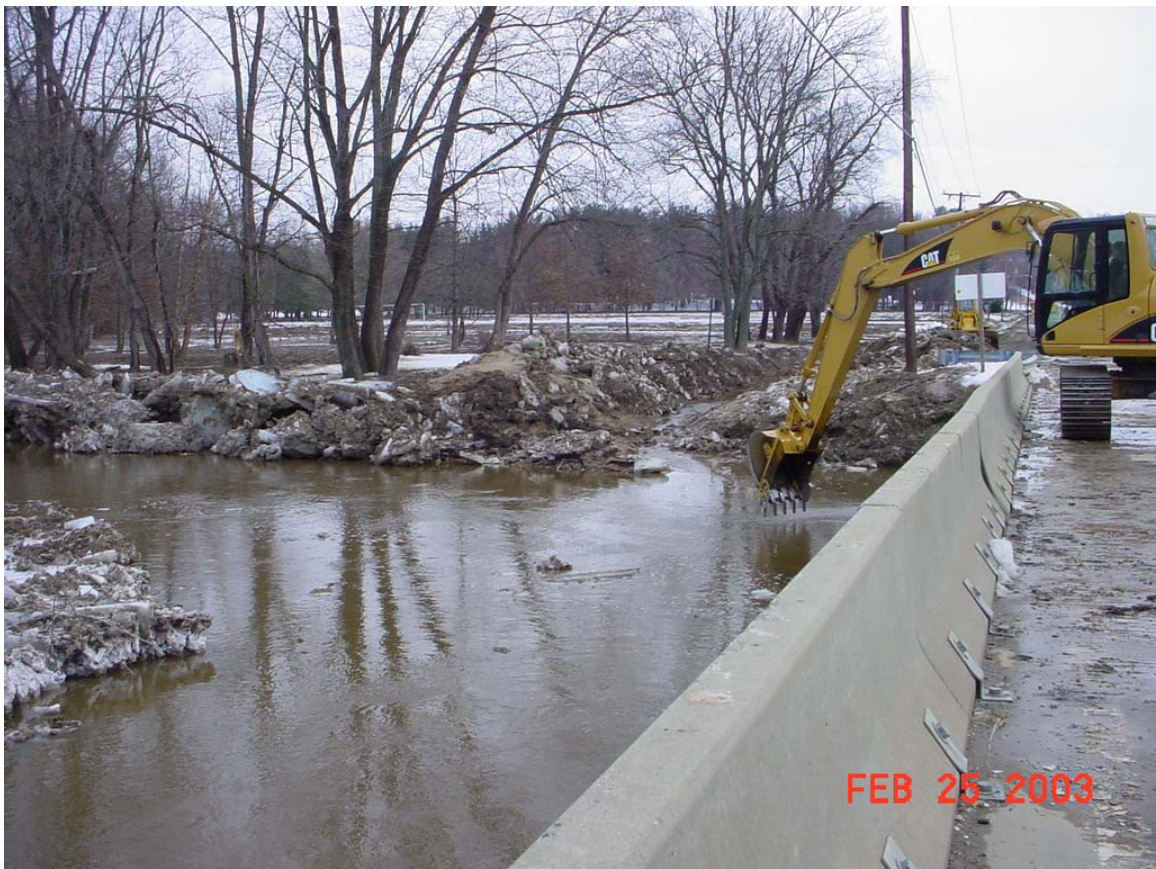
Figure 2

Fluvial flooding problems are very common with Big Elk Creek (Reference 1). Major flooding events occur due to hurricanes, thunderstorms, and other mid-latitude storm that are swept across the area due to the jet stream. Most recently, a late-winter rainstorm in February 2003 produced flooding and ice jams due to severe cold weather during most of the winter (Figure 1). The Delaware Avenue Bridge was damaged by the ice jams to the point that repair crews were needed (Figure 2).
